The Impact of Cleaning and Disinfecting on Medical Device Plastics

Comparison of Plastic Materials: A Case Study

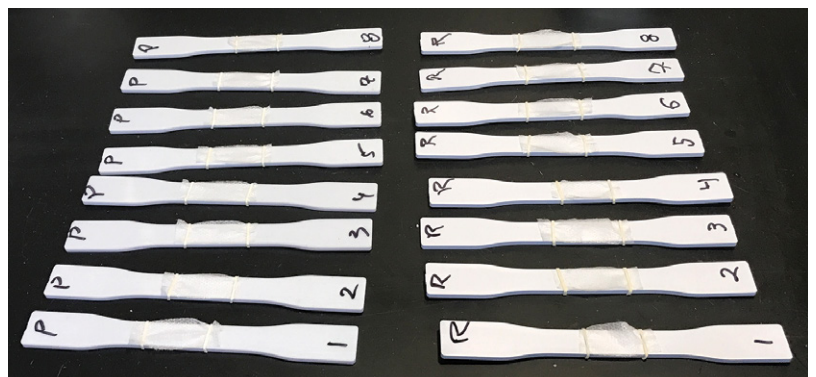
Figure 2. Raw sample stock of two materials prior to testing: (Left) Polycarbonate (Right) Custom-blended plastic used in Verathon BladderScan i10
